An Approach to Debugging Radiated EMI from DC/DC Converters

MPS Webinar

April 6, 2022

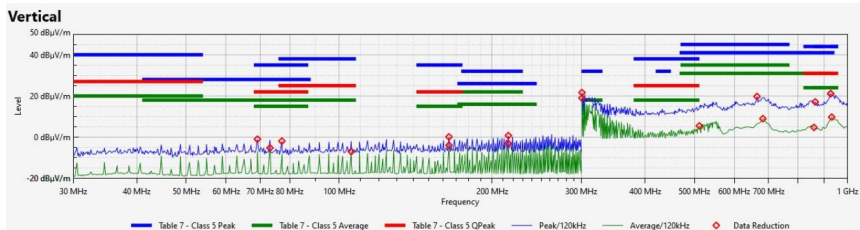
Board modification #1 – comparison

No significant improvements

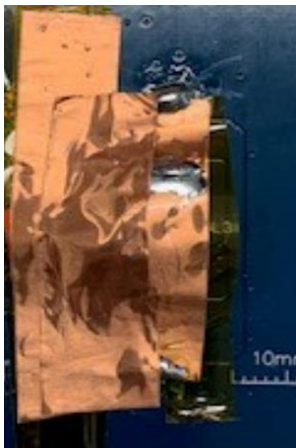
- Locate and shield MPQ9842 buck converter
- Output L still shielded, C1A removed

- Cover IC with SIL pad
- Cover SIL pad with Kapton tape
- Cover Kapton with Cu tape
- Solder Cu tape to GND
